*Office of Oversight
Independent Technical Review of*

The West Valley Demonstration Project Event

April 1997

Office of Environment, Safety and Health

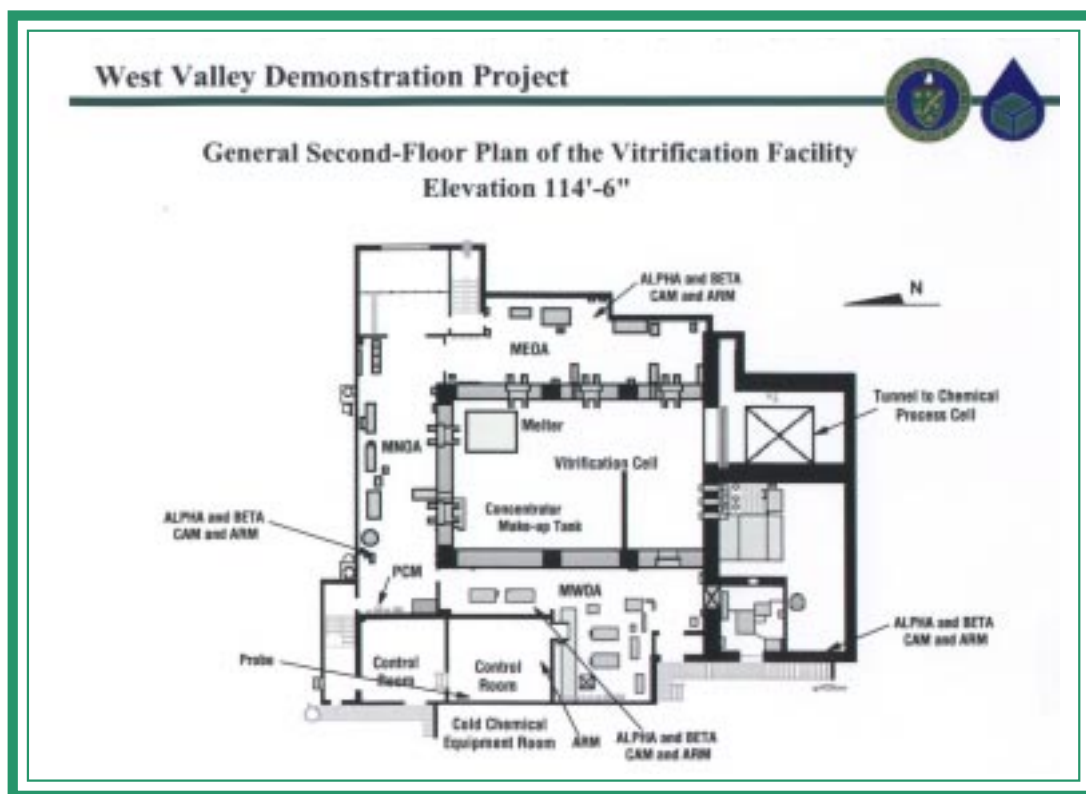
MNOA - Middle North Operating Aisle
MEOA - Middle East Operating Aisle

MWOA - Middle West Operating Aisle

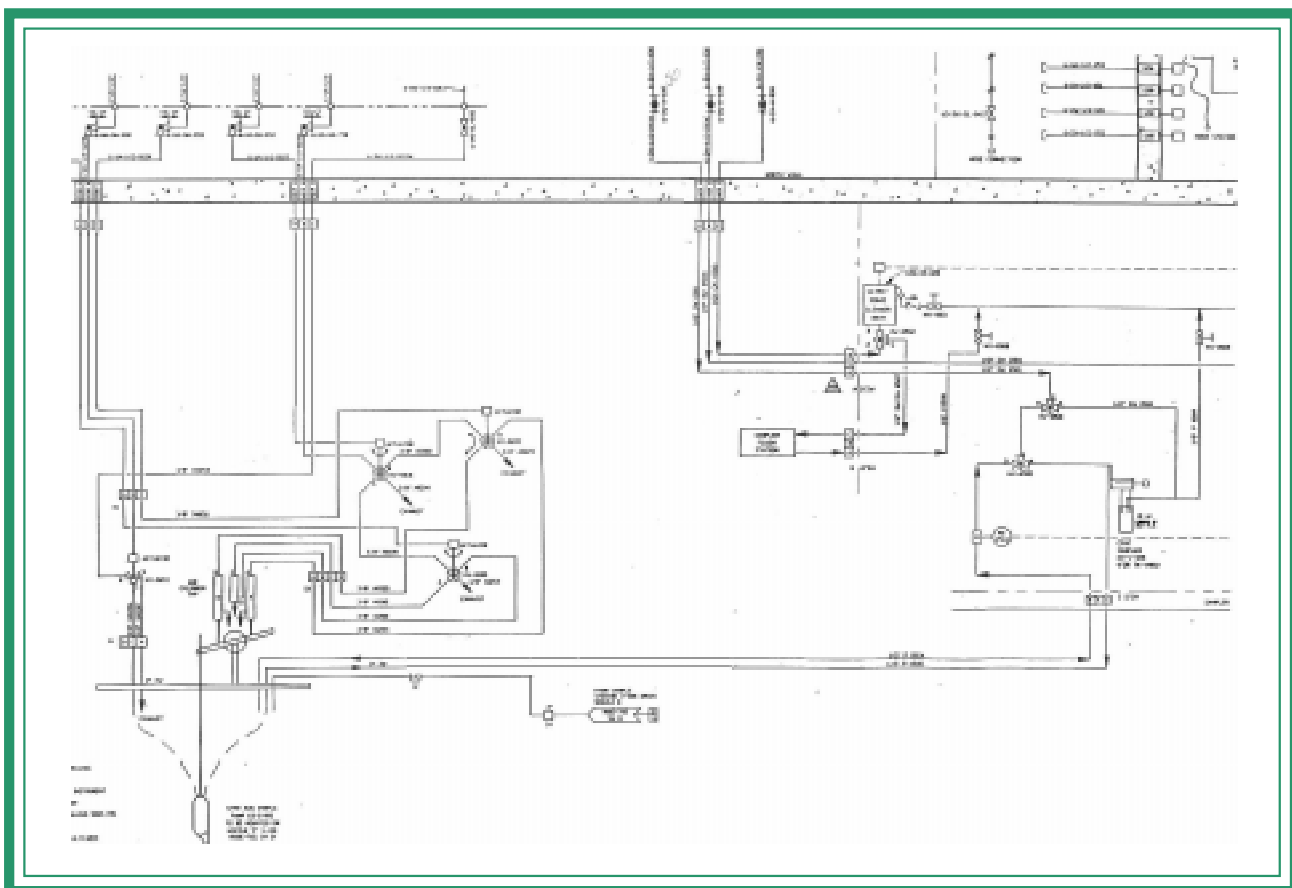
Sample System Piping Diagram

the chamber into the sample system. A simplified diagram is provided above. Valve HV-0213 is normally in the vent-to-CFMT position. When the chamber is opened to the tank, the slurry displaces the air or water in the chamber, filling the chamber.

of piping, valves, and a specialized sample connection that is remotely operated with manipulators. When the sample is drawn, the sample pump produces flow through the sample bottle. The operator then captures the sample by closing the sampler.
